Watershed Assessment, a Critical Component of Stream Restoration

Greg Phillips

GBM^c & Associates

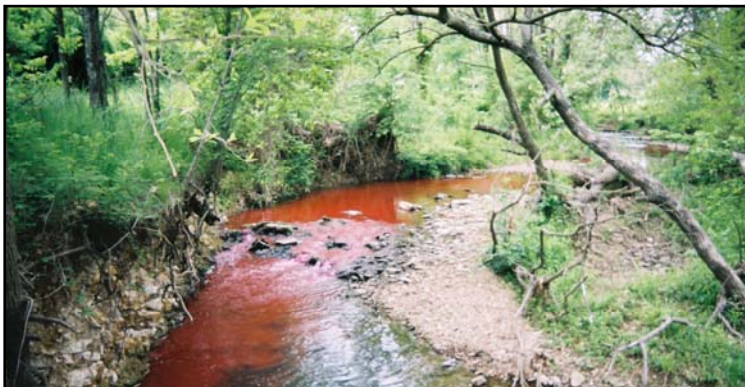
Dye tracer study to determine time of travel in Sager Creek.

completed to characterize the streams stability and identify reference morphology. Various other activities were completed including flow monitoring, time of travel studies, GIS landuse assessment and rapid bioassessments. After the physical, chemical and biological nature of the stream and its watershed were appropriately characterized, several critical areas of concern were identified. These included insufficient riparian buffers to protect the stream banks and filter storm water runoff, three run-of-the-river dams that were negatively impacting hydrology, elevated sediment and nutrient levels in runoff from construction sites and grazed pastures in the watershed and elevated peak flows instream associated with impervious areas in the cities urbanized zone. Each of these concerns resulted in recommendations for protection, enhancement and restoration alternatives for Sager Creek. The basic issue became how to reduce sediment and sediment born phosphorus in the basin and in turn allow the resulting load of these pollutants to transport downstream naturally without building up or being detained in the downstream pools created by the dams. Recommendations included establishment of new vegetated riparian buffers along the creek and enhancement of the existing buffers, dam removal, channel improvements between existng dam locations and the addition of instream morphology and habitat, implementation of a suite of agricultural best management practices (BMPs), installation of storm water treatment features and use of low impact development techniques in critical areas of the watershed. All of these recommendations were designed to meet the goals of decreased nutrient levels and an improvement in the aesthetics of the stream in the downtown area.
